Application Note

90S+ Splicer Error Code and Troubleshooting Quick Guide

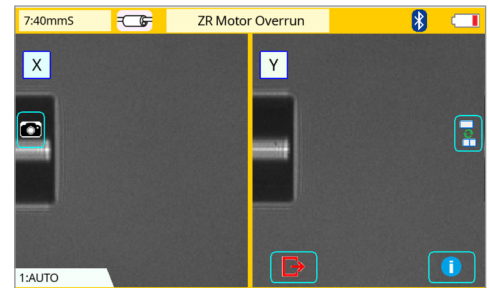
Figure 1

ZL/ZR Motor Overrun means the motor ran to its full extent, but the fiber position is not correct (**Figure 1**).

- Either the cleave length is too short or a loose buffer tube is preventing the splicer from pulling the fiber into the center.
- Make sure the end of the fiber is between the edge of the V-groove and the center line of the electrodes, and if there is a loose buffer tube present, use the sheath clamp switch or a loose buffer fiber holder to keep the fiber from pistoning within the buffer tube.

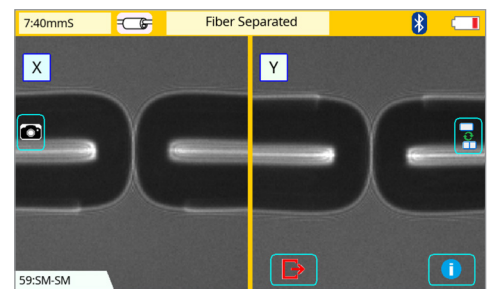
Figure 2

Fiber Separated occurs when the fibers burn back rather than fusing together (**Figure 2**).

- Often, this results from using the wrong type of fiber for performing an arc calibration. This can make the standard arc power too powerful, causing fiber separation.
- Perform an Arc Calibration only with standard G.652 SMF for arc calibration.
 - If the error persists or is limited to one splice mode, call the 24/7 support line at 1-800-235-3423, Opt. 3.

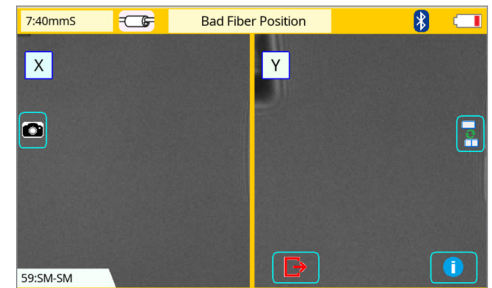
Figure 3

L/R Bad Fiber Position indicates the fiber is outside the field of view of the camera (**Figure 3**).

- Press [Reset] and then re-seat the fiber, ensuring it sits correctly in the bottom of the V-groove.
- Clean the clamp chips.

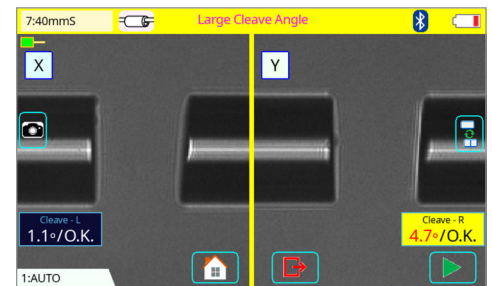
Figure 4

Large Cleave Angle indicates the angle of the fiber's end-face is larger than the threshold allowed by the splice mode (**Figure 4**).

- Clean the cleaver pads and the cleaver blade, then try the cleave again – in most cases this will resolve the issue.
- Check the cleave count for that blade position. If it's at or close to 1250 cleaves, then the blade position is worn. Rotate the cleaver blade.
- Clean the camera lenses.

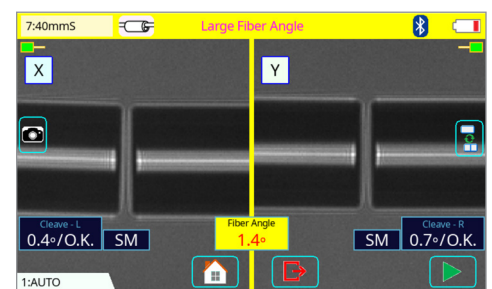
Figure 5

Large Fiber Angle means the fibers are approaching each other at an angle (**Figure 5**).

- Clean the V-grooves and make sure the fibers lay properly in the V-grooves. If using fiber holders, make sure the fiber holders are seated fully on the guide pins.
- Clean the clamp chips.

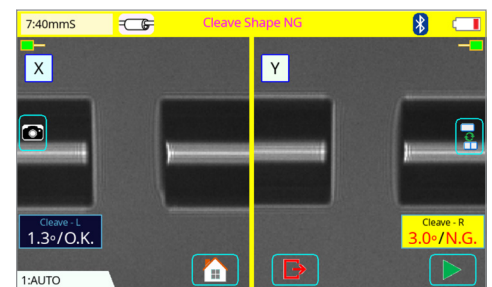
Figure 6

Cleave Shape NG means the end-face of the fiber is not flat and smooth (**Figure 6**).

- Clean the cleaver and re-prepare the fiber – in most cases this will solve the problem.
- If the cleaver blade is worn, rotate to an unused blade position.
- Clean the camera lenses.

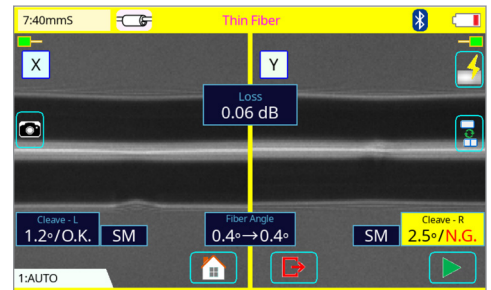
Figure 7

Thin/Fat/Too Tapering Fiber indicates the fiber is too thin, or fat, compared the splicer's standard for a quality splice (**Figure 7**).

- **Thin:** Most likely, the arc is too powerful, causing excessive melting that is not enough to fully separate the fibers
 - Perform an arc calibration with standard G.652 SMF and try the splice again.
 - If the error persists or is limited to one splice mode, call the 24/7 support line at 1-800-235-3423, Opt. 3.
- **Fat:** Generally, this is related to arc power as well.
 - Perform an arc calibration with standard G.652 SMF and try the splice again.
 - If the error persists or is limited to one splice mode, call the 24/7 support line at 1-800-235-3423, Opt. 3.

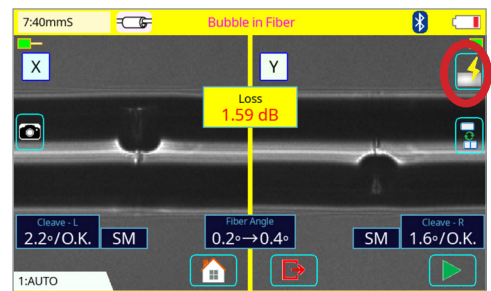
Figure 8

Bubble in Fiber indicates a deformity is detected at the splice point, usually arising from contamination on the fiber end-face or from a bad cleave shape.

- A true bubble will appear as a dark circle at the splice point. Verify it is a bubble by pressing the **Re-Arc** button after the splice. If the occlusion changes or the spot grows, then it is a bubble. Break and re-splice (**Figure 8**).
 - Be sure to follow the proper “Strip, Clean, Cleave” preparation procedure. If the cleave shape is an issue, refer to the “Cleave Shape NG” section above.
- A Bubble can sometimes arise when splicing dissimilar fibers, or highly multimode fibers. This is the result of a line appearing at the splice point (see **red arrows** in **Figure 9**). This line does not affect splice loss, and the Bubble error can be handled by adjusting the “Bubble Sensitivity” setting in the splice mode.

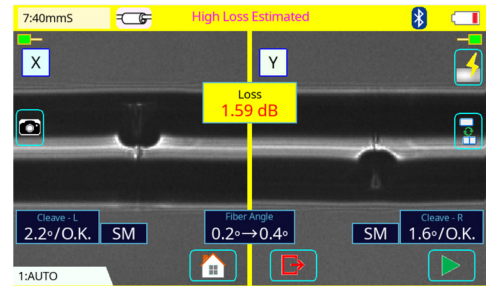
Figure 10

High Estimated Loss could arise from many causes of this error, including the following (*Figure 10*):

- Improper fiber cleaning
- Bad fiber end face
- Bubble at the splice point
- Dust or dirt in the V-groove
- Dust or debris on the camera lens
- Bad electrode condition
- Uncalibrated arc power
- Incorrect splice mode
- Improper arc parameters
- Inadequate estimation parameters

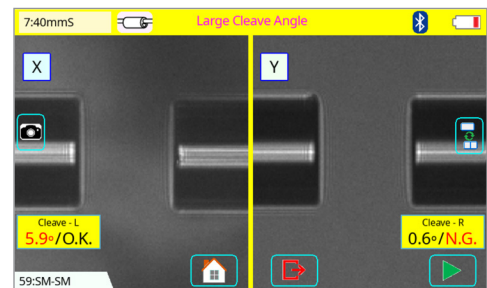
Figure 11

Dust After Dust Check (*Figure 11*)

- Clean the camera lenses with a lint-free cotton swab and 99% or greater Isopropyl Alcohol, starting from the center and swirling outward toward the edge of the lens. Flip the cotton swab to the opposite end and use the same motion to dry any excess solvent off the lens. Discard and use a fresh cotton swab to clean the other lens.
- Dirty lenses can cause false readings of both large cleave angle and bad cleave shape.
- If the error persists, call the 24/7 support line at 1-800-235-3423, Opt. 3.
